Manhole Inspection Summary

Manhole # S41G__027MH

Record Plat: **41G** Node: **027** Status: **Found**

Location Address: **222 s eden st**

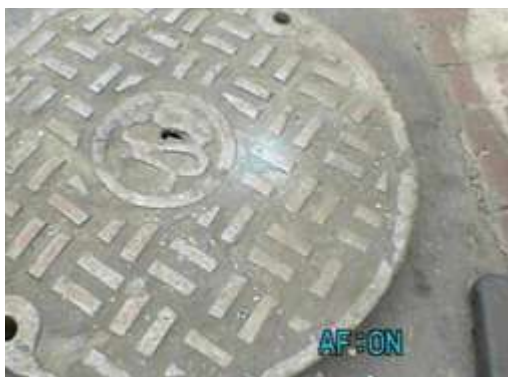
Type: **Sanitary** Condition: **Worn** Cover Material: **Cast Iron**

worn cover

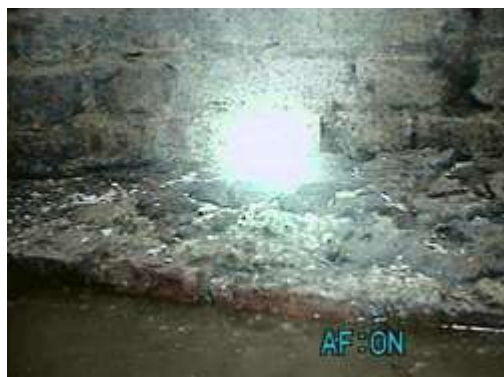
Defect 3

Condition: ☐ Sound ☐ Cracked ☐ Root Intrusion ☐ Deteriorated ☐ Leaks ☒ **Debris**

bench debris

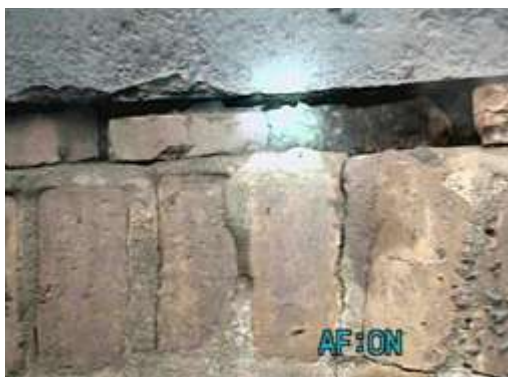
Defect 1

Condition: ☐ Sound ☒ **Cracked** ☐ Root Intrusion ☒ **Loose Brick** ☐ Deteriorated

Cracked and missing bricks in chimney/frame adj

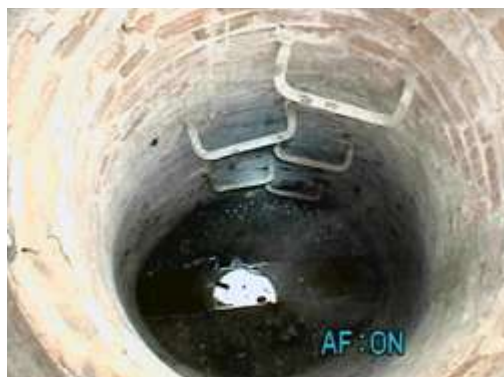
Defect 4

Steps Count: **5** Missing: **0** ☒ **Corroded**

cor. steps

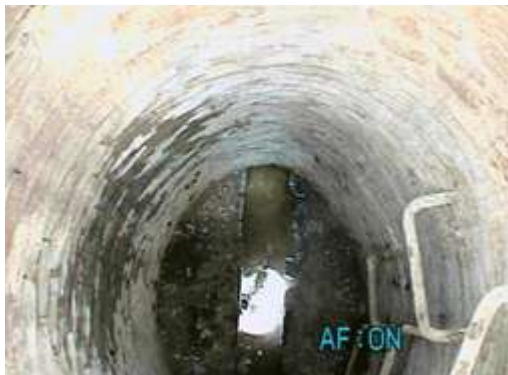
Defect 5

Infiltration: ☐ None ☐ Joint ☐ Cracks ☐ Mortar ☐ Roots ☒ **Wall**

Barrel seepage at wall
